Milan / Paylink Firmware Version 4.1.9.8 Release Notice.

This is a **FULL** (4) release of the Milan / Paylink Interface firmware - code version **1.9.8** and supersedes release 4.1.9.6.

This release implements the new Escrow and Barcode facilities described in the latest user guide.

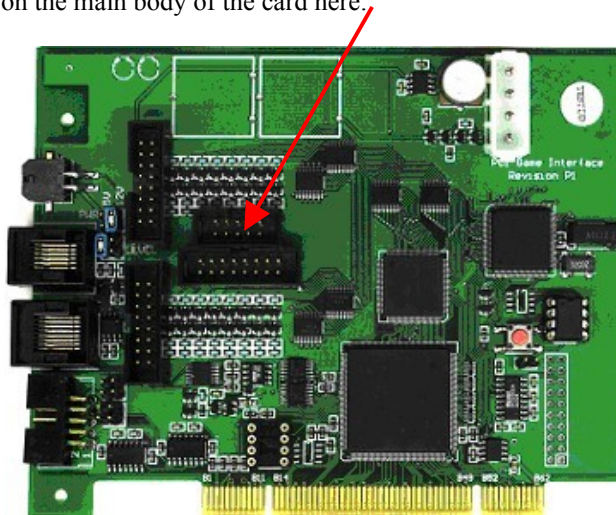
The ID-003 and GPT Argus V2.2 acceptor protocols are now supported on the multi purpose RS232 port. This port has multiple uses, which require totally different communications drivers. The default (and at present only) method of specifying which driver to use is with **a jumper** on the utility inputs. These inputs are located on the main body of the card here:

These utility inputs are numbered (with the card in this orientation) as:

9	7	5	3	1
10	8	6	4	2

JCM / GPT acceptor support on PCI Card.
